Technical Series

00-138

PERFORMANCE OF A BRICK VENEER/STEEL STUD WALL SYSTEM

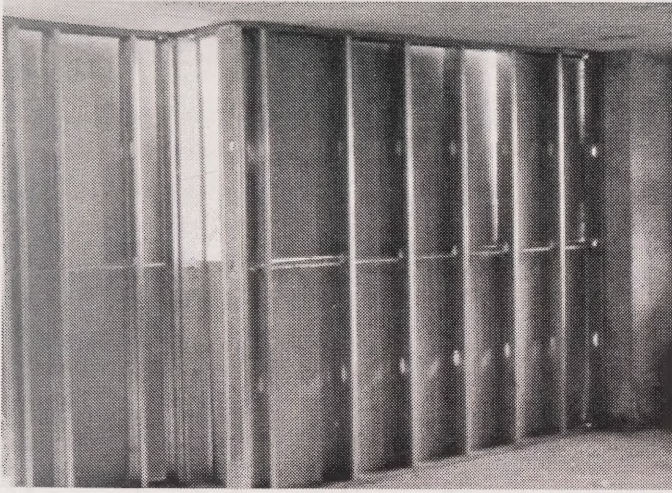
Photograph 1: Framing and Exterior Sheathing

The sheathing is not fastened against the framing yet, but when it is, gaps will remain at the joints that make the sheathing the least air-tight layer in the wall.

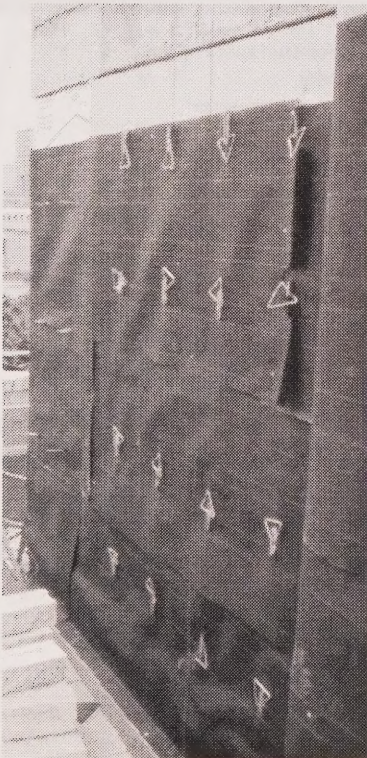
Photograph 2: Sheathing Paper and Masonry Ties

The sheathing paper is lapped to drain, but will not be a barrier to exfiltration. The corner column is insulated on the exterior with rigid extruded polystyrene insulation. At the bottom of the cavity, rigid insulation on the slab edge (covered with paper in this view) extends outward from the plane of the wall, narrowing the cavity at the bottom.

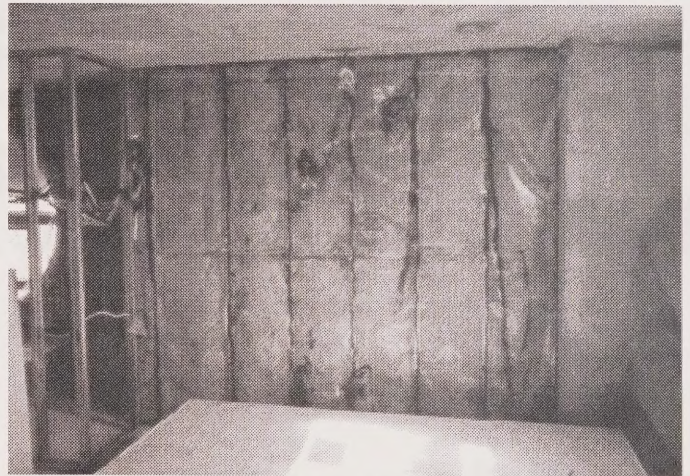
Photograph 3: Insulation and Vapour Barrier

Photograph 3 shows the wall during construction, with studs, insulation and vapour barrier in place.

The polyethylene vapour barrier is sealed at laps and to adjoining concrete. Electrical outlets have polyethylene back pans, and other penetrations are sealed. For a wall that depends on the vapour barrier to be an air barrier as well, it is reasonably tight.

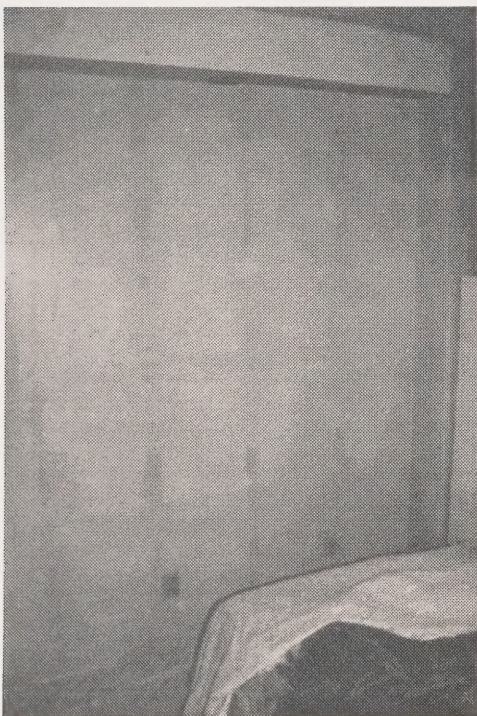
Photograph 5: Dust Staining at Stud Locations

In -20° C weather the interior surface was as much as 3.5° C colder at the stud locations than midway between studs. Severe dust patterns indicating stud locations (and even drywall screws) were observed after the first year, as can be seen in **Photograph 5**.

Thermal bridging: indoor surfaces at stud locations are colder in winter than the surfaces between studs. More dust is attracted to the cooler surfaces, resulting in the staining seen here.

- Insulation on the exterior, in the cavity, sufficient to keep the gypsum sheathing above the interior air dewpoint temperature (this will also reduce thermal bridging of framing).
- Better airtightness, to reduce latent heat loss and reduce condensation in brickwork.
- A larger minimum cavity depth, to promote drainage and drying.
- Better venting of the cavity (arranged to exclude rain).

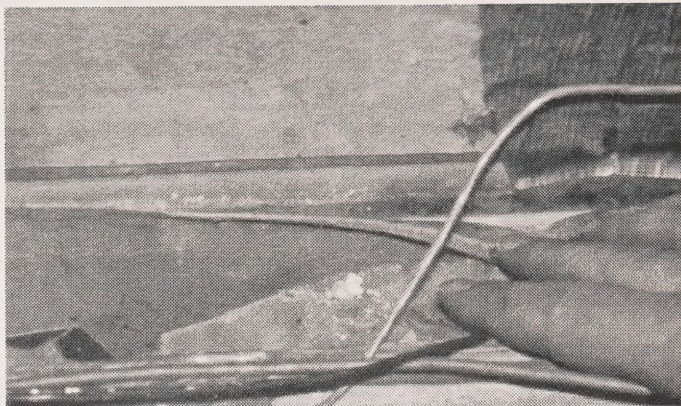
Photograph 6: Mildew or Mold on Interior Surfaces of Exterior Sheathing

The corresponding situation was similar for the back of the sheathing and the dewpoint temperature of the air in the stud space. While the coldest part of the stud, the exterior flange, was always warmer than the dewpoint temperature of the air in the stud space, the inside face of the sheathing midway between studs was consistently below dewpoint temperature. The mold seen on the back of the sheathing after a year, shown in **Photograph 6**, is further evidence.

When the wall was opened, this staining was visible on the interior side of the exterior sheathing—here at mid-height, and to a greater extent at the base of the wall.

- There was no frost or surface moisture on the brick, which appeared fairly dry.
- The building paper and exterior sheathing were very wet and significant amounts of mildew were observed on the interior side of the sheathing, especially at the bottom.
- The insulation in contact with the exterior sheathing was wet.
- Corrosion of the framing was minor. The bottom track showed zinc oxidation (white rust) and signs of periodic wetting. Otherwise, there was rust only on cut edges, screw tips and shavings.
